Challenge

Issue

After 20 years in service, corroded pump internals reduced flow and efficiency. Client sought options to high capitol replacement cost with long lead time.

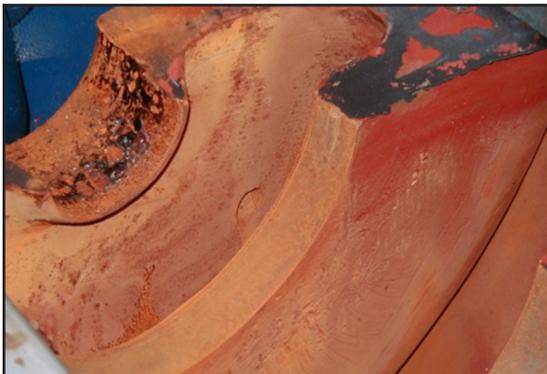
Corrosion and erosion from entrained solids degraded internal tolerances and increased frictional drag through hydraulic passages.

Eroded and corroded pump volute

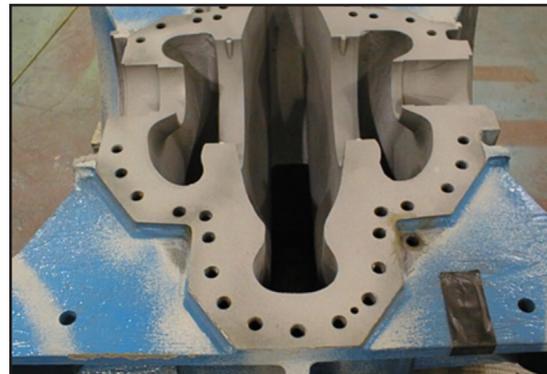
Surface after proper surface preparation

- Decontaminate surfaces
- Grit blast to Sa 2.5 with 3 mil (75 µm) angular profile

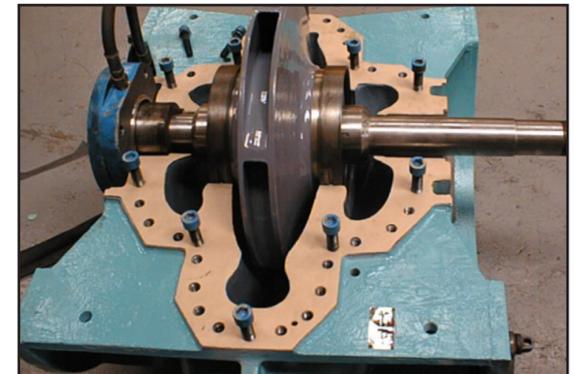
ARC-coated surfaces - casing and impellor

1. Apply **ARC 858** to fare smooth and fill pitted surfaces rebuilding tolerances
2. Apply 2 coats of **ARC S2** @ 15 mils (375 µm) DFT per coat
