Challenge

Reduced MTBR (22 days) of NiHard wear plate increased maintenance and spare parts carrying costs (\$27K/plate).

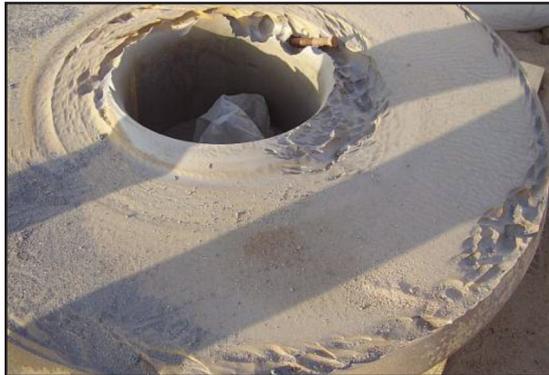
Abrasive fines in acidic tailings slurry wears NiHard plates.

Damaged wear plate at 22 days

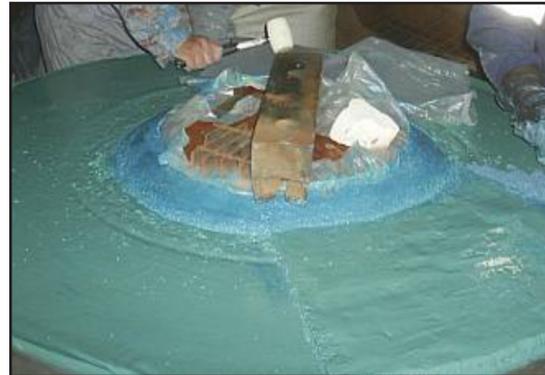
Applying ARC MX1 over primer coat of ARC S2

- Grit blast to Sa 2.5 with 3 mil (75 µm) angular profile

1. Apply one coat **ARC S2** @ 10 mil (250 µm) as primer
2. Apply **ARC MX1** @ 500-600 mil (12-15 mm)
3. Apply two coats **ARC S2** @ 20 mil (500 µm) as overcoat

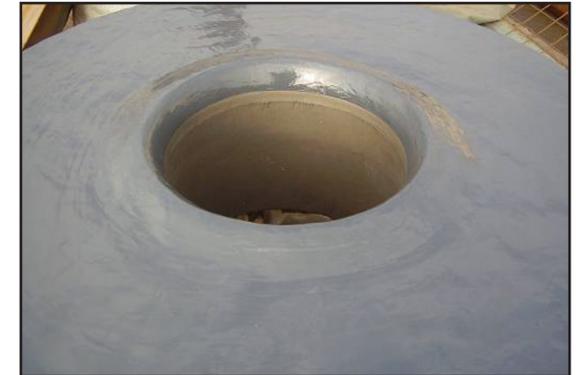
Completed wear plate ready for service
