Challenge

Turbulent flow damages stay vanes, creating cavitation zones which impact turbine efficiency. Costly hard-face welding involves extensive downtime with poor results.

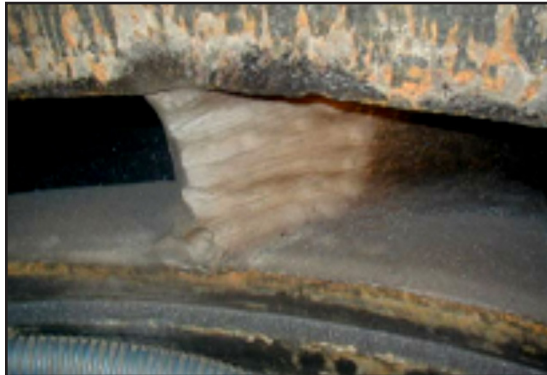
Metal loss due to abrasive solids in the water.

Grit blasted stay vane

- High pressure water clean at 100 bar (1400 psi)
- Closed circuit grit blast to Sa 2.5 and a 3 mil (75 µm) angular profile

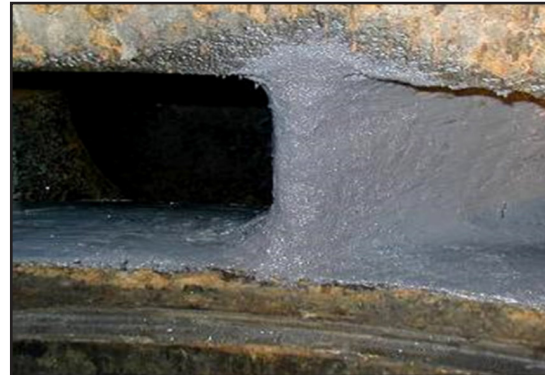
Rebuilt with ARC 858 and ARC 897

1. Apply **ARC BX2*** to fill gaps >120 mils (3 mm) depth
2. Apply **ARC 858** as surfacing coat @ 20 mils (500 µm)
3. Overcoat with 2 coats of **ARC S2** @ 10 mils (250 µm)

*ARC BX2 is the "Bulk" package size of ARC 897

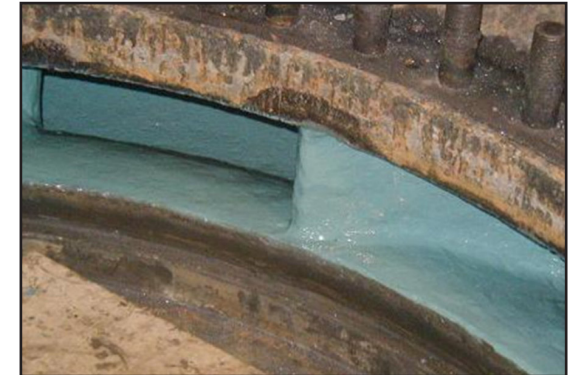
Top coated with 2 coats ARC S2

- Applied ARC 80% faster than hard-faced welding (3 days vs 10 days)
- Rebuilt surface, reduced turbulent water flow
- Increased efficiency and run time
- Continuous runtime extended to 18 months
