Challenge

Performance loss after <12 months reduced influent flow. Option was to install additional pump to achieve flow demand.

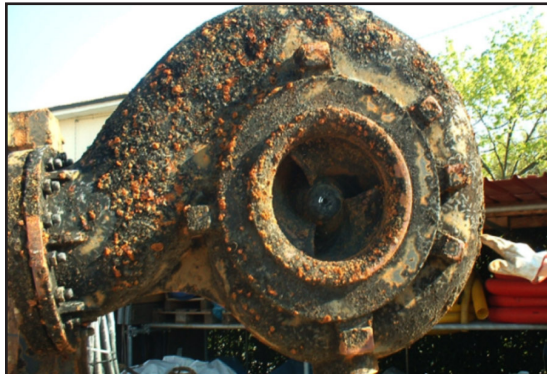
Corrosion exfoliation and scale build-up in pump was reducing flow and performance.

Eroded and corroded pump

- Apply **ARC 858** to fare smooth pitted surfaces and rebuild worn areas to tolerances
- Apply 2 coats of **ARC 855** to internals for corrosion/erosion resistance
- Apply 1 coat of **ARC 855** externally for corrosion resistance

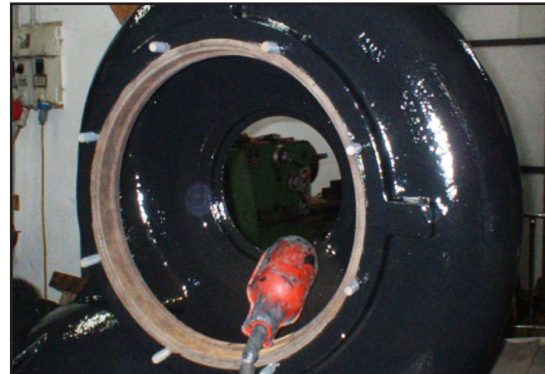
ARC coated surface after proper surface preparation

- Pressure wash and decontaminate surfaces
- Grit blast to Sa 2.5 with 3 mil (75 µm) angular profile

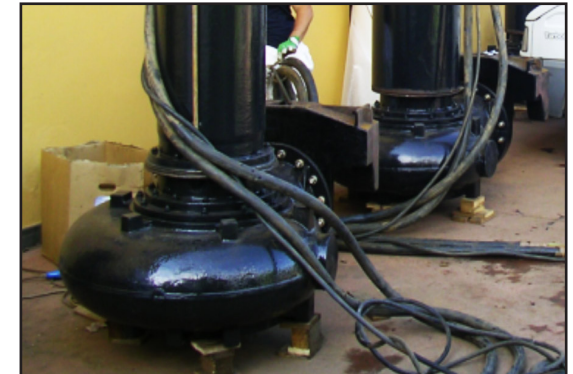
Pumps ready for delivery

- Reduced scaling and corrosion exfoliation returning pump to required flow
- ARC coating and upgrade cost 35% less than new pump purchase
- Avoidance of new pump purchase \$25,000
- ARC repair:** -\$16,250
