# By Using Chesterton ARC 858, Saves Customers Time And Money!

Specify Industry  
Product: Chesterton  
Case Study 000 IL/MRO

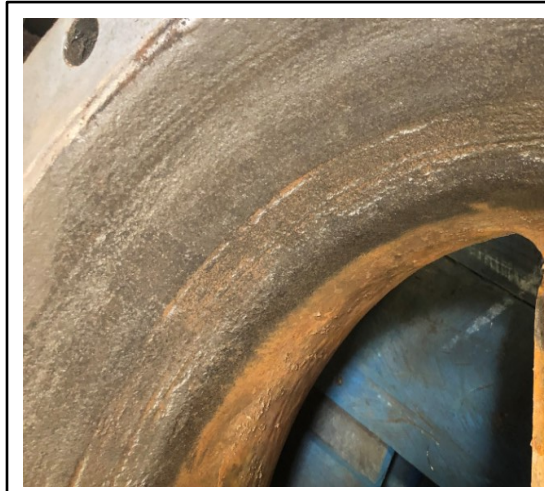
This is a 25" suction bell from a large Vertical Turbine Pump. The wear area of the suction bell was severely damaged, the customer wanted this suction bell replaced with new. The new suction bell had a 16 to 18 week lead time, so the customer then requested that Phoenix Pumps, Inc. (PPI) conduct the repair utilizing ARC 858.

**Severely damaged suction bell before being repaired with ARC 858.**

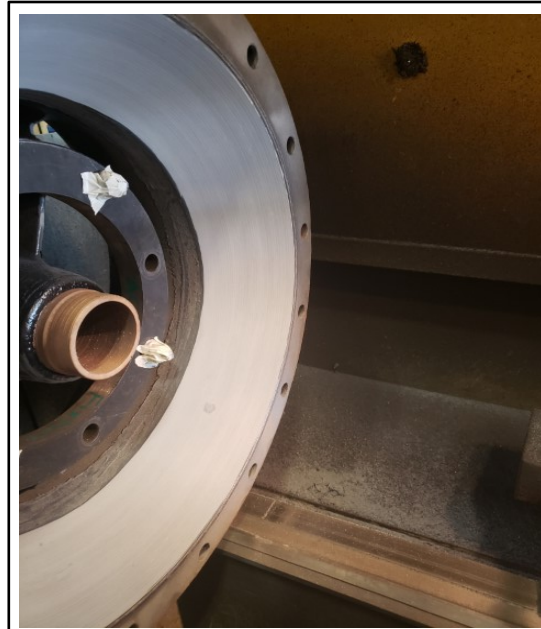
**Suction bell being machined after ARC 858 was applied.**

After machining the wear ring area, the PPI Repair Division applied Chesterton ARC-858 and was able to repair the suction bell in a couple of days.
